NATO CCMS Pilot Study: Environmental Aspects of Reusing Former Military Lands

Liepaja, Latvia Special Economic Zone
Phase II Site Visit and Proposal Evaluation

May 1997

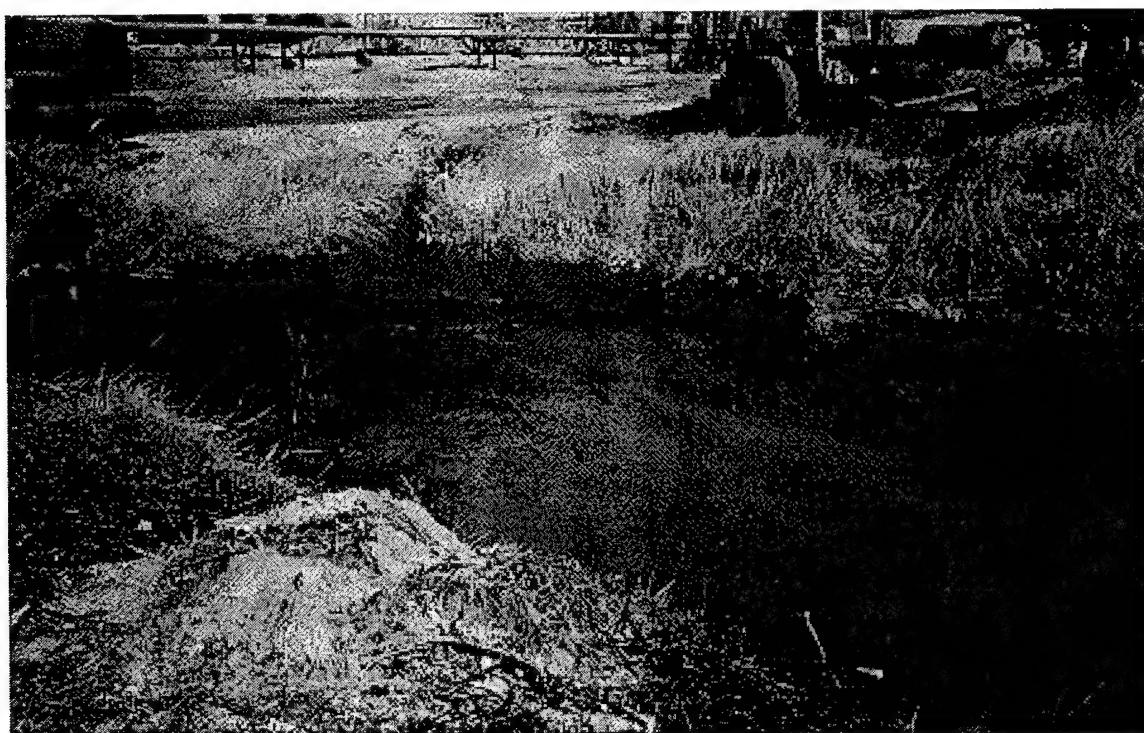
- Two petroleum tank farms where substantial hydrocarbon spills and leakage are known to have occurred (Figures 2-5).
- Ship, torpedo and missile repair shops where solvents, fuels, and heavy metals were commonly used (Figures 6 & 7).

Figure 5 - Fuel Overflow and Waste Dumping Pit in Tank Farm Area

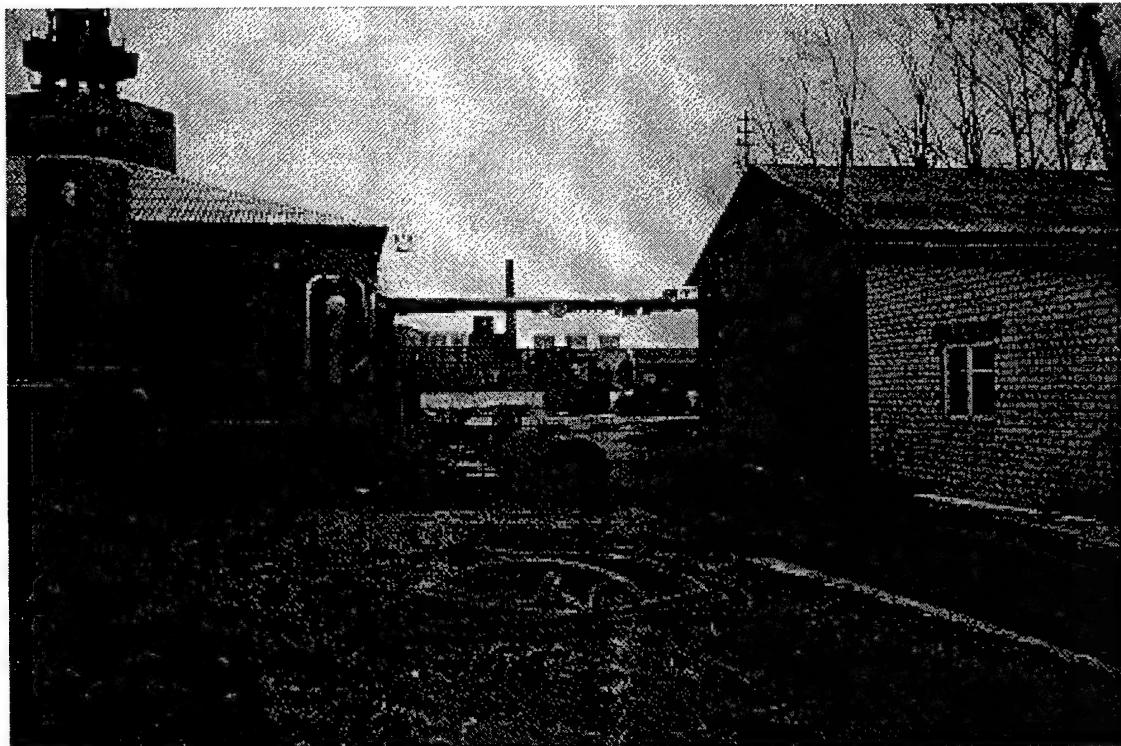
Figure 7 - Torpedo and Missile Repair Facilities

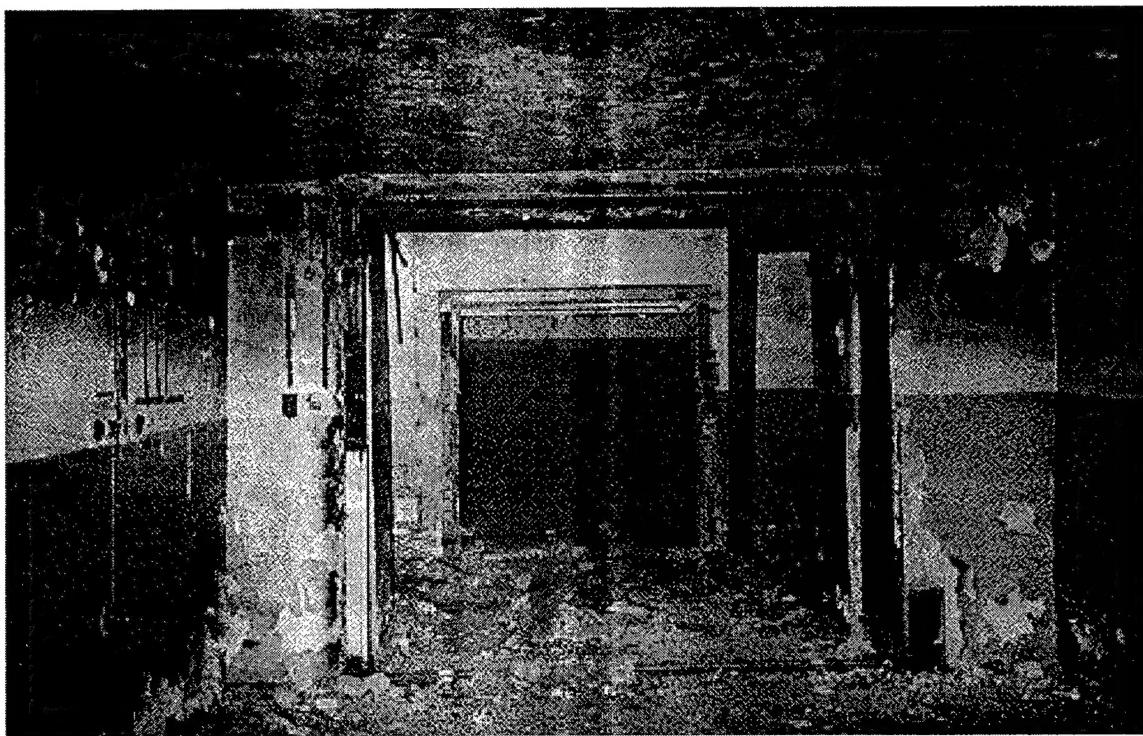
- An extensive array of former ammunition and explosives warehouses, bunkers and other holding structures which may contain explosive materials and debris (Figures 12 & 13).

Figure 12 - Missile Storage Bunker in Northern Karosta

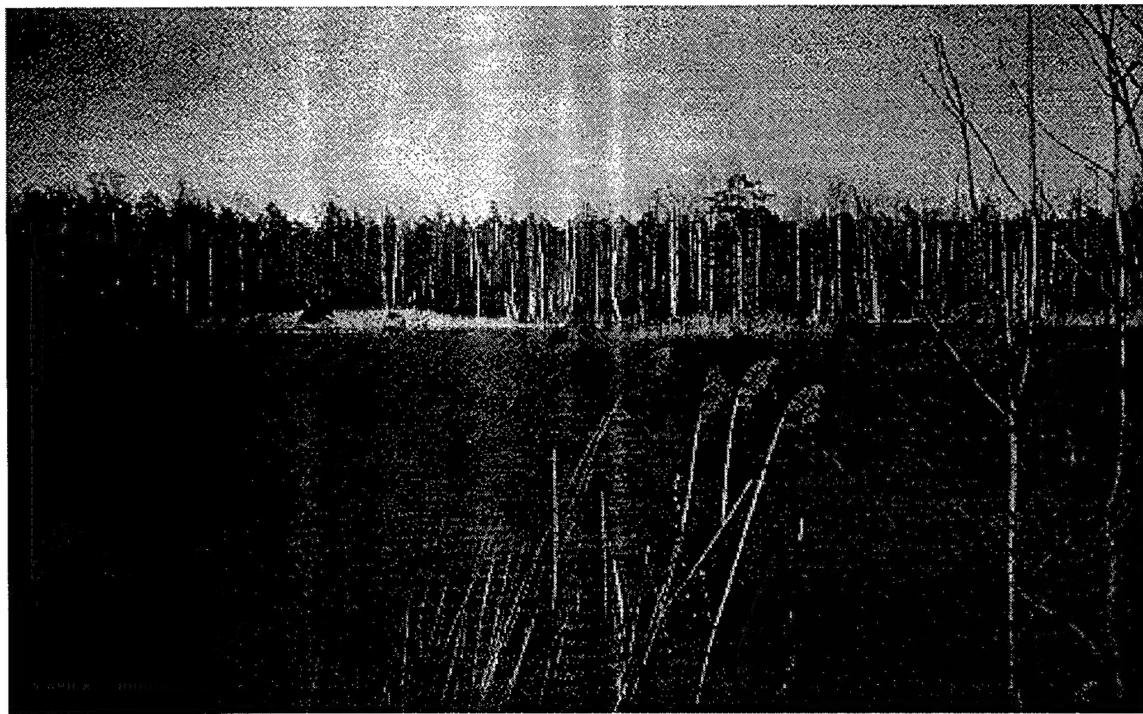
Figure 13 - Fire Suppression Water Storage Pond and Suspected Ordnance Dump

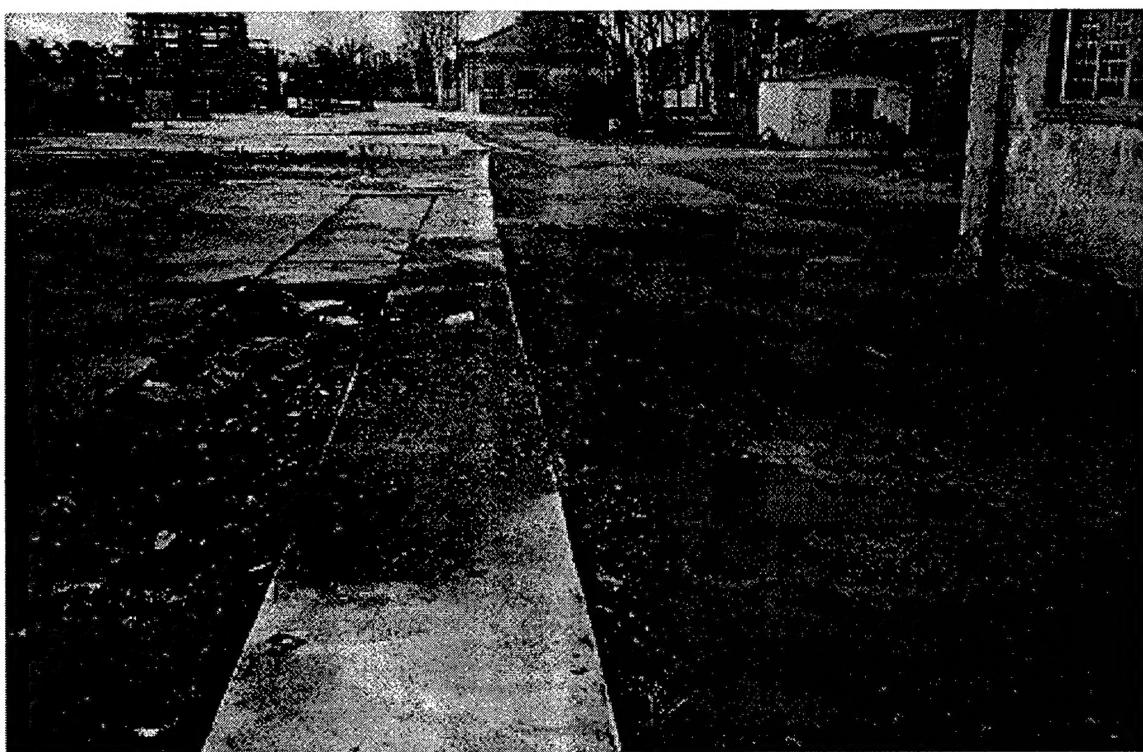
- Miscellaneous sites throughout the Karosta and Liepaja Harbor, particularly near industrial shops, fuel storage and transfer facilities, railroad lines, scrap yards, and piers suggesting the presence of petroleum hydrocarbons, solvents and heavy metals (Figures 14-17).

Figure 14 - Typical Stained Site in Industrial Area

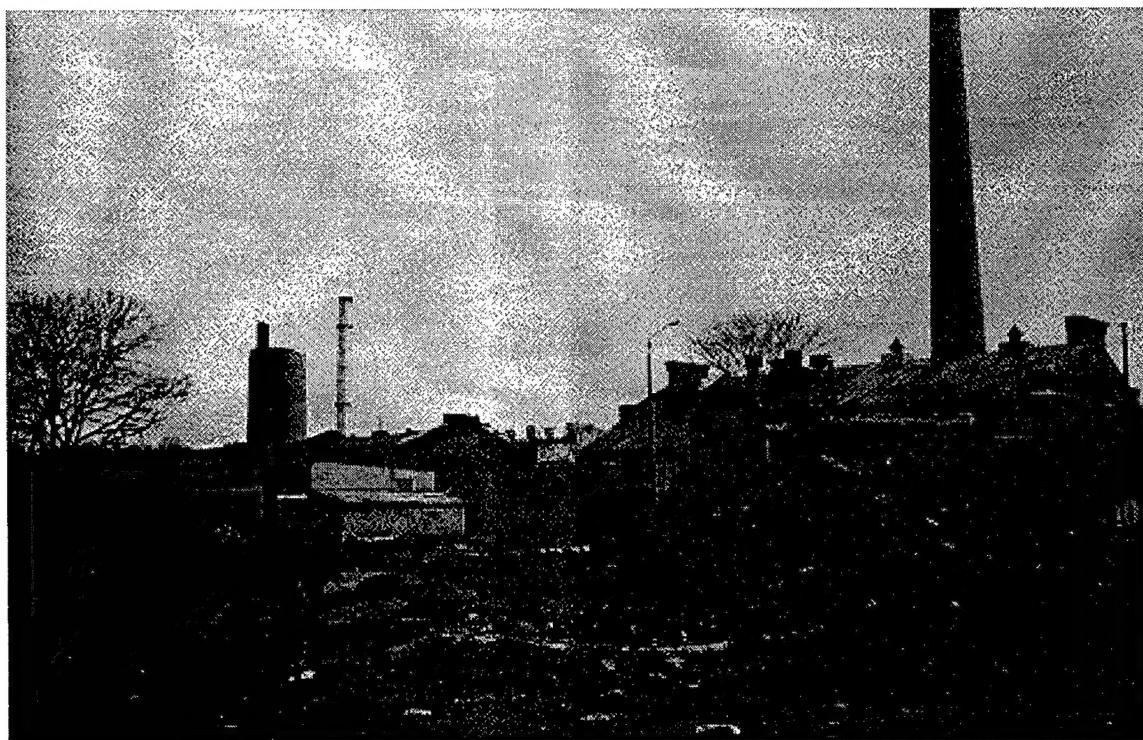
Figure 15 - Industrial Area Scrap Yard
